Manhole Inspection Summary

Manhole # S19A1_015MH

Insp Date: **5/30/08 12:53 PM**

Location Address: **2003 harman av**

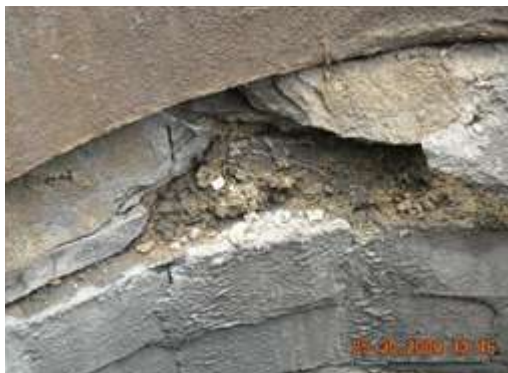
Defect 4

Condition: ☐ Sound ☒ **Cracked** ☐ Root Intrusion ☐ Loose Brick ☐ Deteriorated

cracked chimney

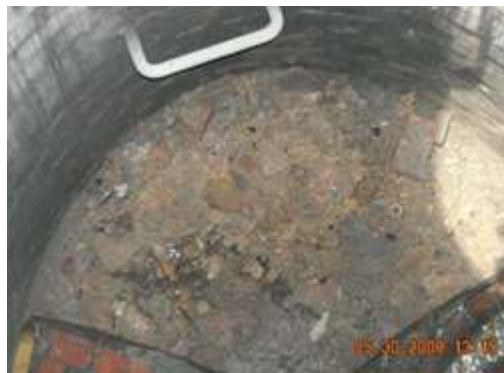
Defect 3

Condition: ☐ Sound ☐ Cracked ☐ Root Intrusion ☐ Deteriorated ☐ Leaks ☒ **Debris**

debris on bench

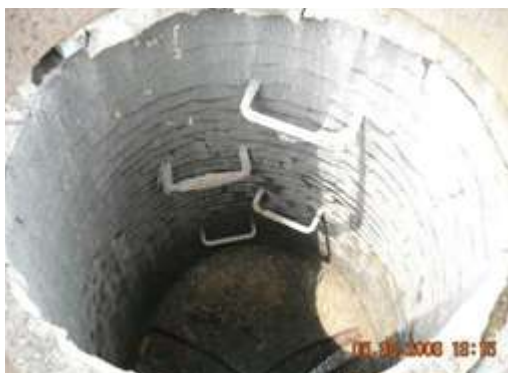
Defect 2

Infiltration: ☐ None ☐ Joint ☐ Cracks ☐ Mortar ☐ Roots ☒ **Wall**

Count: **4** Missing: **0** ☒ **Corroded**

corroded steps, infiltration @ barrel wall

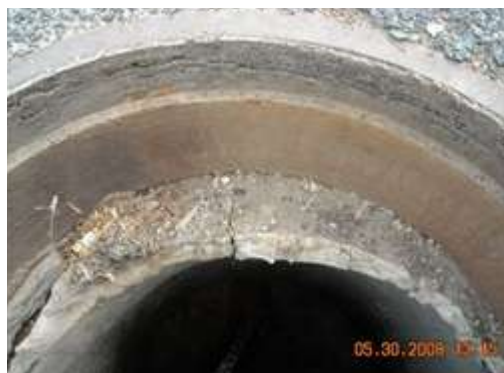
Defect 1

Offset: **3** (in.)

frame offset

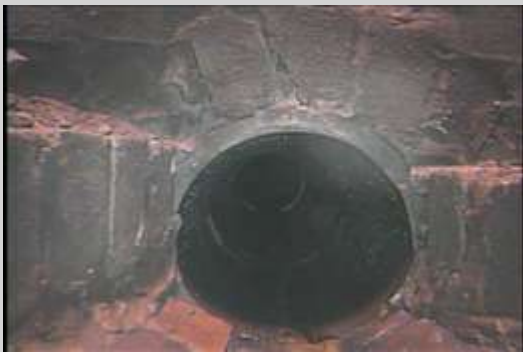
12 O'Clock Outflow

Pipe Height: **8.4** (in.) Rod and Bar (Angled)
Pipe Material: **Clay** ☐ Pipe Lined
Invert Depth: **8.50** (ft.) Flow Characteristics: **Slow**
Deposits: ☒ None ☐ Mud ☐ Sludge ☐ Debris ☐ Grease
Silt Depth: **0** (in.) Deposits Extent:
Infiltration: **None** Pipe Seal Cond: **Sound**

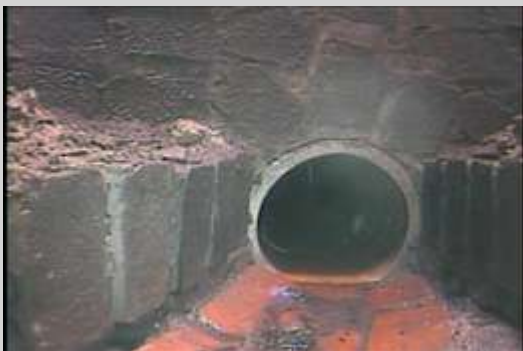
3 O'Clock Inflow

Pipe Height: **6** (in.) Rod and Bar (Angled)
Pipe Material: **Clay** ☐ Pipe Lined
Invert Depth: **8.30** (ft.) Flow Characteristics: **Slow**
Deposits: ☒ None ☐ Mud ☐ Sludge ☐ Debris ☐ Grease
Silt Depth: **0** (in.) Deposits Extent:
Infiltration: **None** Pipe Seal Cond: **Sound**

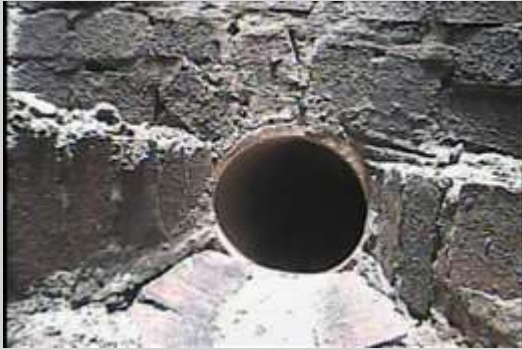
9 O'Clock Inflow

Pipe Height: **6** (in.) Rod and Bar (Angled)

Pipe Material: **Clay** ☐ Pipe Lined

Invert Depth: **8.10** (ft.) Flow Characteristics: **Slow**

Infiltration: **None**

Pipe Seal Cond: **Sound**
